FINAL ASSESSMENT REPORT

KJG Project No. A2023.024

A Site and Facility Assessment for the Jerolaman Long Site 1004 E. Market Street Logansport, Indiana 46947

Cass County Historical Society 421 Broadway Street Logansport, Indiana 46942

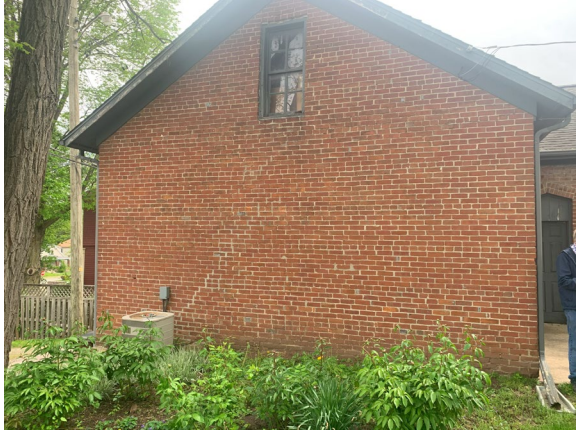
We observed the west gable-end wall to not be perfectly plumb (see Pictures 1 & 2). The wall bows out slightly to the west just above the second floor level, and then the top of the wall leans slightly east. This characteristic is noticeable when standing parallel with the wall. However, KJG observed no significant cracks in the wall or other indications of recent movement. Evidence of previous tuckpointing is apparent, but that work does not appear recent and remains intact. If the wall had experienced measurable movement since the previous tuckpointing, KJG would expect to see noticeable horizontal and stair-step cracks, particularly around the second floor level. But we judged the only need for tuckpointing to be near the base of the wall where rain and snow have worn down some of the mortar joints.

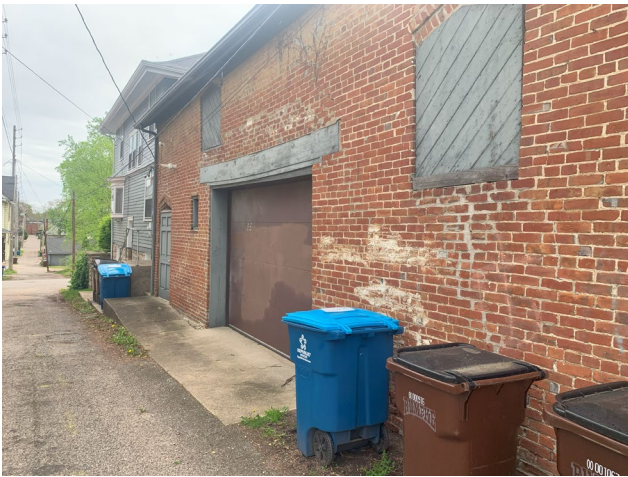
The north loading door has a large timber header above it which supports the weight of the brick wall above the opening and the second floor framing (see Pictures 3 & 4). The header appears original and has deflected downward several inches at its mid-span over the years. It is normal for wood to creep (i.e. deflect) gradually over time when subjected to continuous loading. The downward deflection appears to have caused significant cracks in the brick above the opening several years ago, but those cracks have been tuckpointed for some time, and no new cracks or other indications of recent movement is visible above the opening. We also did not judge any instability in the second floor structure just inside this opening. In fact, the ceilings of the second floor are covered with modern gypsum board

which is a brittle material susceptible to cracking even with modest structural movement. Yet we did not observe any notable defects in the gypsum board ceilings (see Pictures 5, 6 & 7). While it is possible that further creep could occur in the north timber header, it is our professional opinion that the header is currently stable and not in need of immediate repair unless new cracks become evident above the opening.
