FINAL ASSESSMENT REPORT

KJG Project No. A2023.024

A Site and Facility Assessment for the Jerolaman Long Site 1004 E. Market Street Logansport, Indiana 46947

Cass County Historical Society 421 Broadway Street Logansport, Indiana 46942

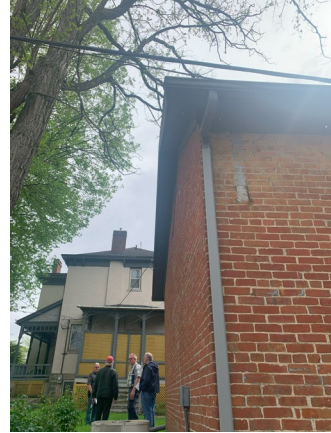
2

We observed the west gable-end wall to not be perfectly plumb (see Pictures 1 & 2). The wall bows out slightly to the west just above the second floor level, and then the top of the wall leans slightly east. This characteristic is noticeable when standing parallel with the wall. However, KJG observed no significant cracks in the wall or other indications of recent movement. Evidence of previous tuckpointing is apparent, but that work does not appear recent and remains intact. If the wall had experienced measurable movement since the previous tuckpointing, KJG would expect to see noticeable horizontal and stair-step cracks, particularly around the second floor level. But we judged the only need for tuckpointing to be near the base of the wall where rain and snow have worn down some of the mortar joints.

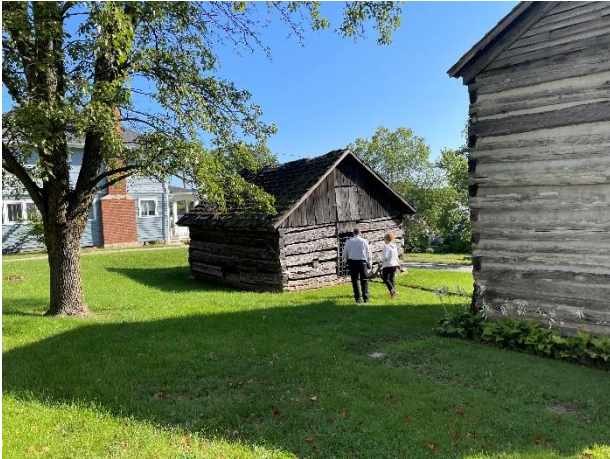
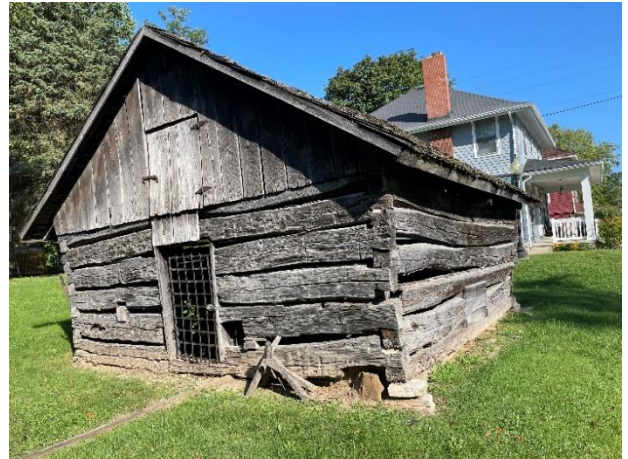
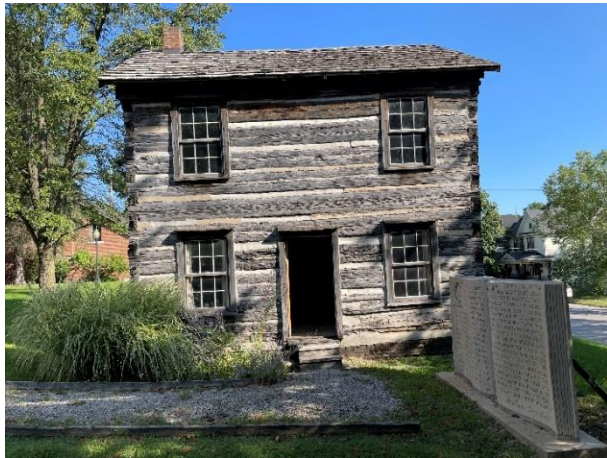
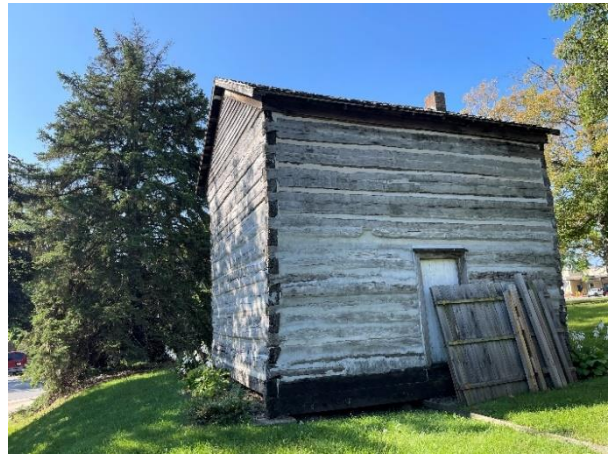
- a. NARRATIVE
 - 1. These structures were relocated to this site sometime in the early 1980s. The exact year of their construction is unknown but is assumed to be sometime in the early 1800s.
- b. ARCHITECTURAL
 - 1. It is the recommendation of KJG Architecture that Cass County Historic Society seek the assistance of experts in this type of construction. Request a survey of the structure and recommendations for maintaining and/or repairing the damage to these buildings.
- c. MECHANICAL
 - 1. There is no mechanical system in these buildings.
- d. ELECTRICAL
 - 1. There is no electrical system in these buildings.
- e. PLUMBING
 - 1. There is no plumbing system in these buildings.
- f. ADA ACCESSIBILTY
 - 1. There is an accessible path to the front door of the cabin. The cabin itself has no accessibility to the interior.
- g. PHOTOGRAPHS

- h. LIST OF PRIORITIES
 - 1. Seek qualified historical log cabin experts to assist with restoration of structures. Request inspection for structural soundness.
- i. COST ESTIMATE
 - Have a third-party expert evaluate the structures \$6,000.00
